DEFENCE SCIENCE AND TECHNOLOGY ORGANISATION MATERIALS RESEARCH LABORATORIES MELBOURNE, VICTORIA

MRL-R-885

CONCENTRATION OF SULPHURIC ACID: PREMATURE FAILURE OF BAMAG POTS

Jeffrey J. Batten & Peter J. Knuckey

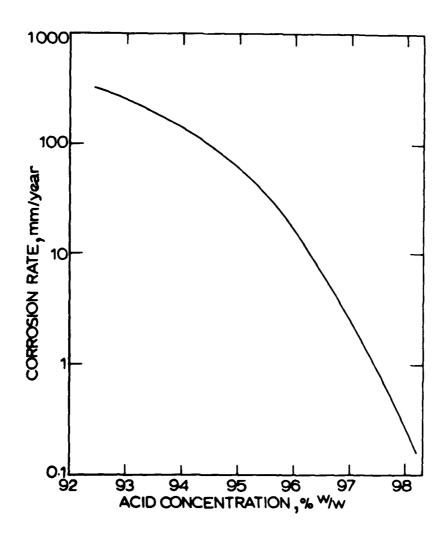
The rate of attack of boiling strong sulphuric acid on cast iron, plotted against acid concentration, is shown in Figure 5. It is clear from this figure that slight changes in acid concentration have a very pronounced effect on corrosion rate [21] and a change in acid concentration from 98 to 92% results in a rate change from insignificant to dramatic. Cast iron possesses no useful resistance to dilute sulphuric acid [14,19,20]. A more complex relation between corrosion and temperature in Figure 6 indicates, however, that for 96% sulphuric acid in the vicinity of its boiling point, the

Factor (a) cannot be readily eliminated however. At the boiling point of 95% acid, slight changes in acid concentration have a very pronounced effect on corrosion rate as is shown clearly in Figure 5. For instance the observed corrosion rate of about 600 mm/y may occur if 92% acid reaches the walls of the cast iron vessel.

FIG. 5 Graph of the variation of corrosion rate of cast iron in boiling concentrated sulphuric acid plotted against the acid strength [21].

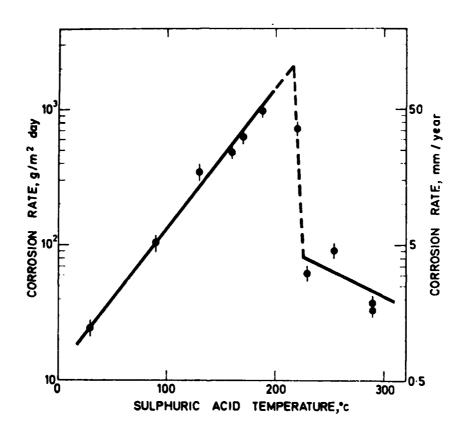
Factor (b) may also be readily eliminated. As shown by Figure 6, a slight cooling from the normal operating temperature possible in the region of the outlet (i.e. where the perforation occurs) could not yield the observed excessive corrosion rates.

FIG. 6 Graph of the corrosion rate of cast iron in 96% sulphuric acid plotted against temperature [18].

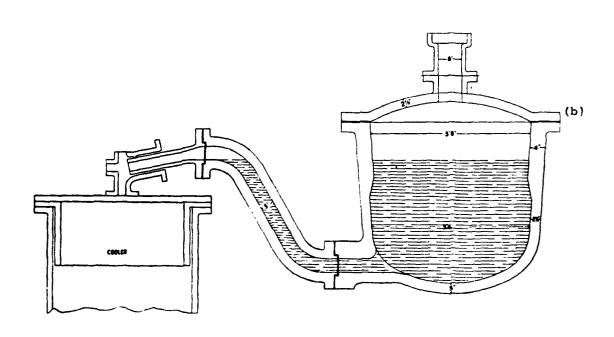
PIG. 7 Cast iron concentrating pots of the Dreyfus type, erected in 1916 to increase the strength of the sulphuric acid from 93% to 96.5% H₂SO₄. In (b) the wall thickness at the acid surface line has been increased to four inches [1].

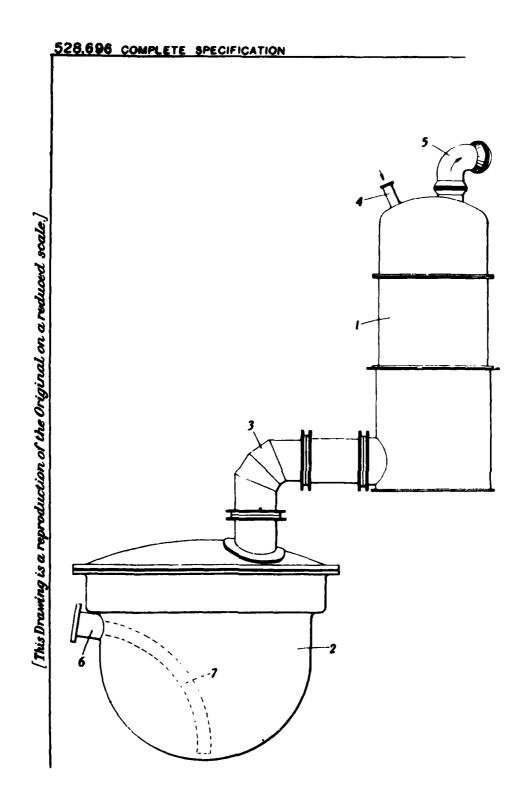
bottom of the still through the wall at the liquid level (see Figure 9).

FIG. 9 Bamag acid concentration plant [7]. Note the siphon-type dip pipe for the overflowing of the concentrated acid.

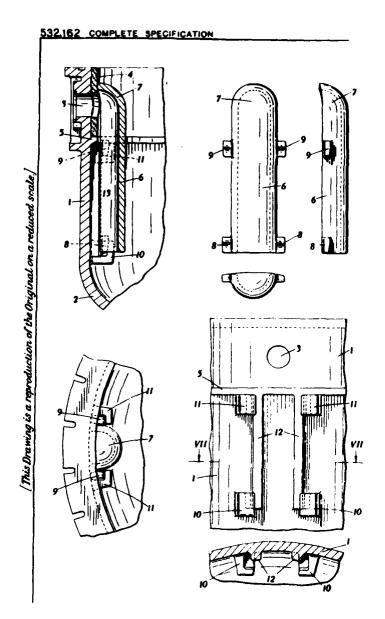
In this connection, the original Bamag specification [8] called for a cowl to block-off the outlet aperture from surface layers of acid (see earlier). The cowl was shaped to accommodate any internal protective ring of tiling at the level of the outlet aperture (as shown in Figure 10). Hence the cowl shown in Figure 15 would not be very effective because there is a 55 mm gap between the upper section of the cowl and the vessel wall. Such a cowl could be made satisfactory, however, by appropriate welding of metal to it to fill this gap or by making the castings of the appropriate shape.

FIG. 10 Bamag cowl [8] that is used to create a substantially closed passage for concentrated liquid from the lower parts of the still to the outlet aperture. The numbers on this figure indicate the following:

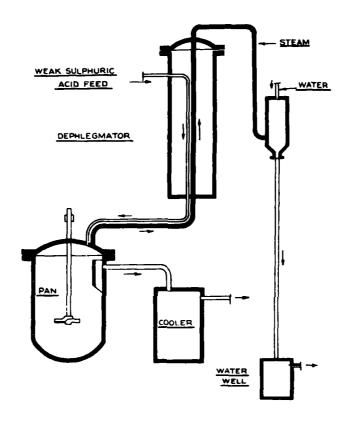
FIG. 11 Diagrammatic sketch of cast iron pot dephlegmator concentrator [9]. Note the cover over the concentrated acid outlet.

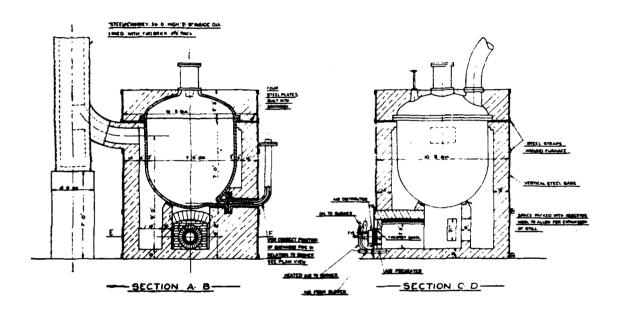
Parrish then discussed the nature of the outlets of these cast iron vessels. Thus, for example, he states that an externally-arranged outlet (see Figure 12) necessitates a core, and may conceivably cause difficulties in casting. Also, when renewing a swan-neck (Figure 7a) it is necessary to syphon out the acid, whereas with the submerged internally-arranged outlet (Figure 13) only part of the acid needs to be removed.

FIG. 12 Cast iron pot with external outlet (swan-neck type) [9].

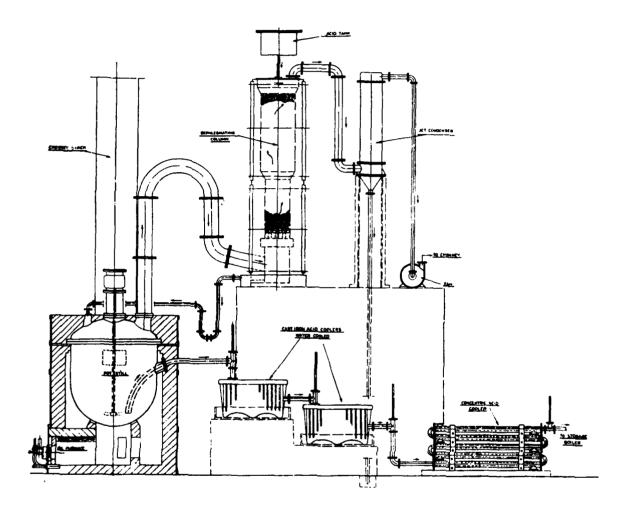
FIG. 13 Diagrammatic layout of complete acid concentrating plant [9].

Note in particular the internally-arranged concentrated acid outlet and its relative position to the weak acid inlet.

(a) The effective acid outlet was located in the body of the acid, as illustrated in Figure 13 - this would remove the influence of the outlet on the surface radial velocity component (as discussed earlier);

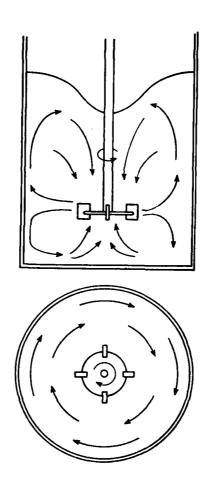
The velocity of the fluid at any point in these pots with their centrally located impeller, and with the concentrated acid outflow located on the liquid/vapour interface, has three components (as illustrated in Figure 14) and the over-all flow pattern depends on the variations in these three velocity components from point to point. The first velocity component is radial, and acts in a direction perpendicular to the shaft of the impeller. It might be expected that this component, at least in the surface layers of the acid, would be influenced by the presence of the above type of acid-outlet and may, therefore, not be radially symmetrical. Also the radial component outwards and on the surface maintains hydrostatic pressure at the vessel Thus it is the authors contention that there is a surface radial component of the flow that is considered to be the major cause of the The second component is longitudinal and acts in a corrosion problem. direction parallel with the shaft. The third component is tangential, or rotational, and acts in a direction tangent to a circular path around the shaft.

It is clear from Figure 14 that the radial and tangential components are in a horizontal plane, and the longitudinal component is vertical. The radial and longitudinal components are useful, and provide the flow necessary for the mixing action. The tangential component is generally disadvantageous, for the tangential flow follows a circular path around the shaft, creates a vortex at the surface of the liquid and tends to perpetuate, by a laminar-flow circulation, stratification at the various levels without accomplishing longitudinal flow between levels.

FIG. 14 Plow pattern with impeller mixer illustrating the three velocity components and vortex formation [30].
